EXISTING CONDITIONS

PAINTING INSTRUCTIONS

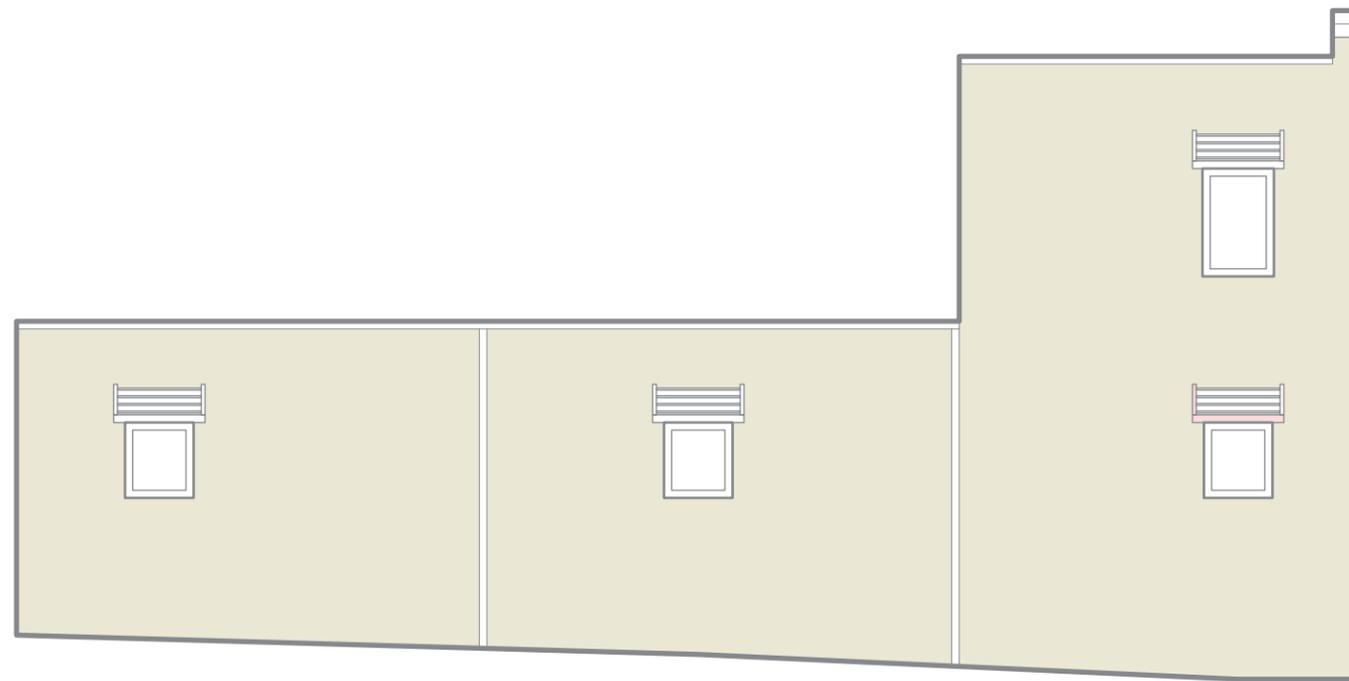
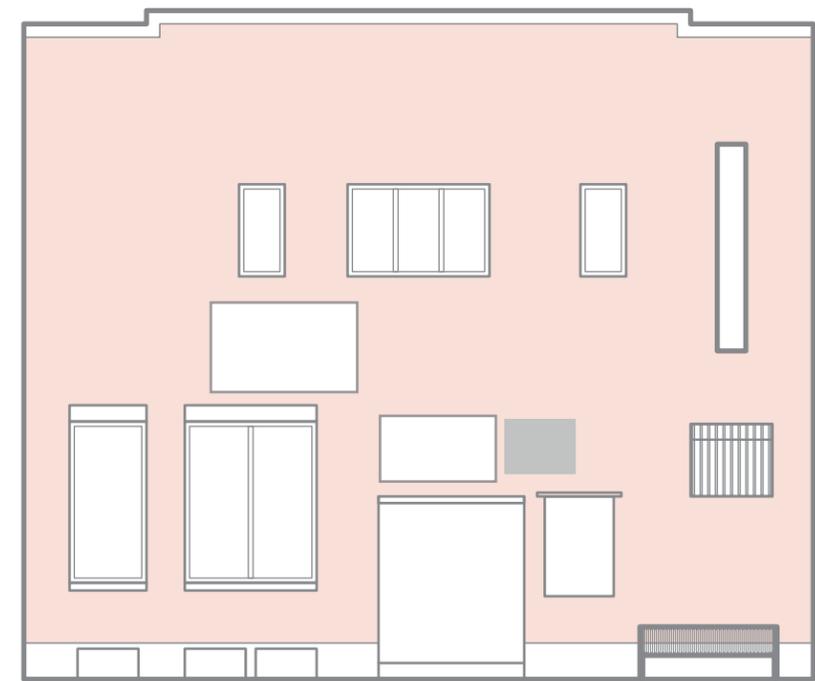
NOTE: MANY GAPS EXIST IN BRICK FACADE;  
 FILL WITH NEW BRICK OR SEALANT AS  
 NECESSARY TO PATCH FACADE

REMOVE EXISTING VINYL SIGNAGE  
 AND FORMER SIGN CONNECTIONS  
 ON FACADE

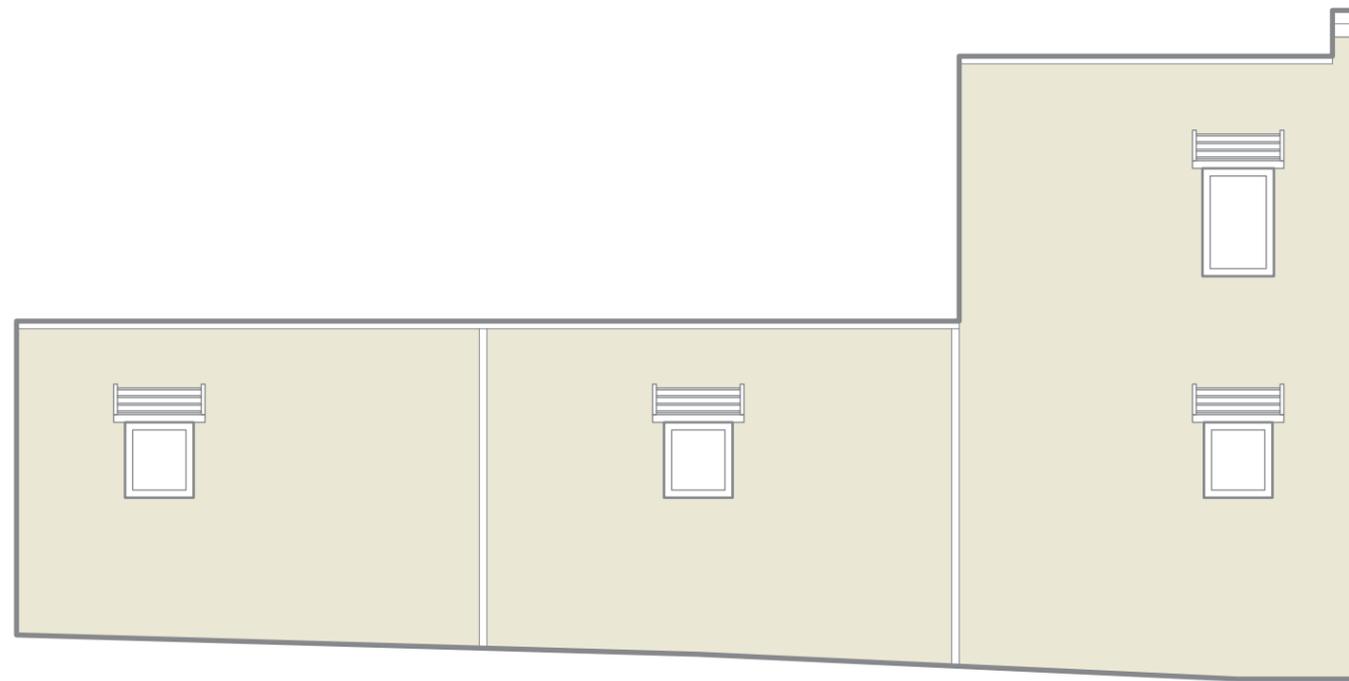
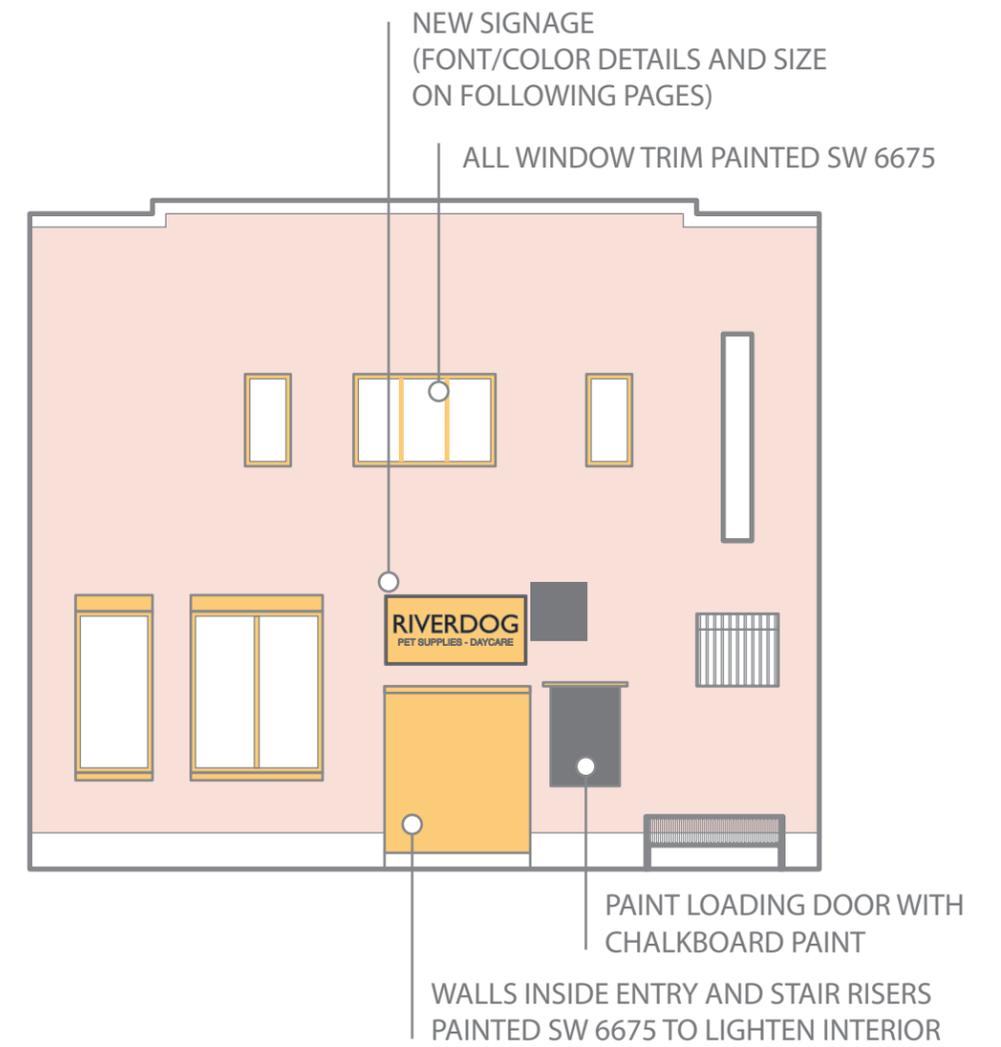
GENERAL NOTE: MANY GAPS EXIST IN BRICK WALL; THESE MUST BE PATCHED AND VERIFIED AS NON-STRUCTURAL OR PROBLEMATIC ISSUE

SIGN BOLTED TO FACADE (6'2" X 3'0"); CENTERED ABOVE DOOR WITH TOP EDGE OF SIGN ALIGNED WITH TOP OF WINDOW LINTELS

ELECTRICAL PANEL PAINTED BLACK

METAL PLANTERS INSTALLED AT LOWER-LEVEL WINDOW SILLS

ENTRYWAY PAINTED SW 6675 TO MATCH TRIM (WALLS OF ENCLOSED ENTRY AND STAIRS)

LOADING DOCK AREA CLEANED AND PAINTED WITH CHALKBOARD PAINT

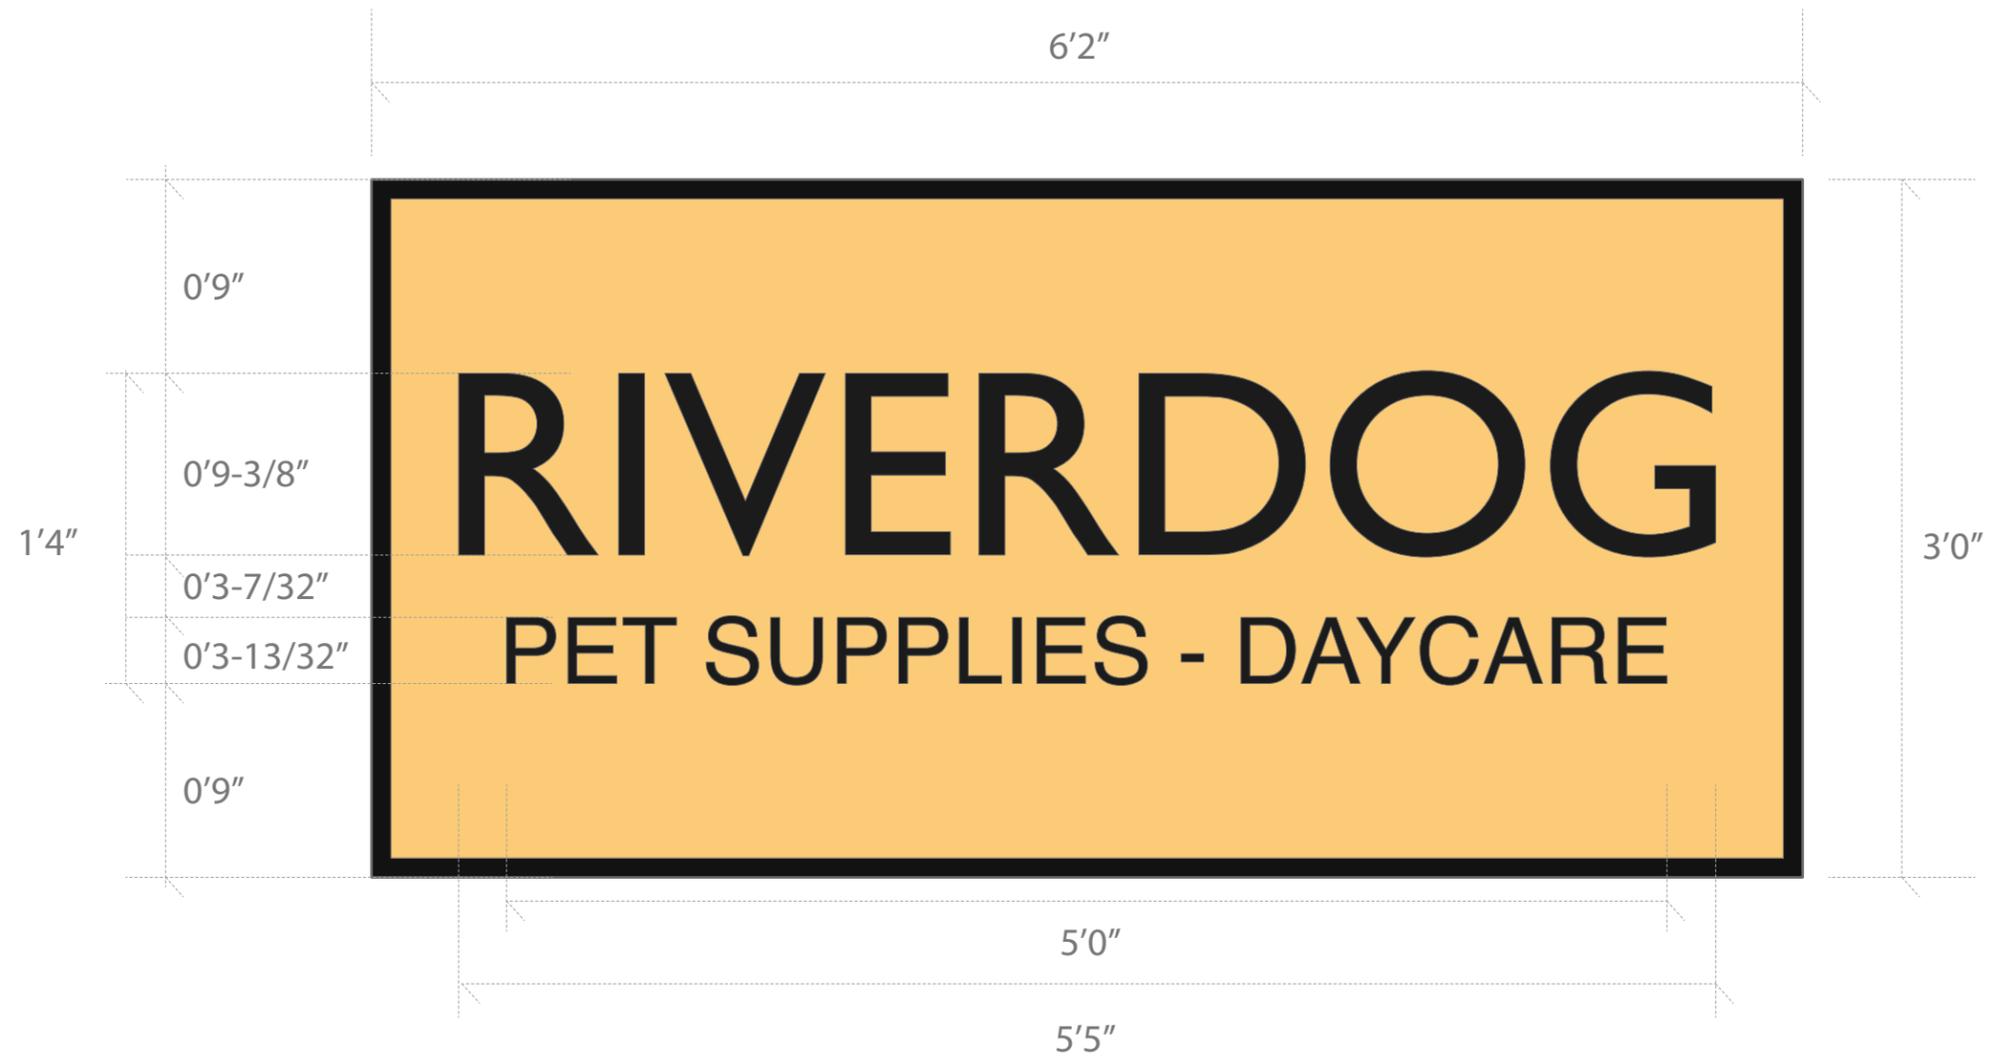
NOTES:  
 CENTERED LETTERING (HELVETICA)  
 RAISED BLACK PVC LETTERING - 1"  
 MATTE PAINT ON SIGN: R-251 G-203 B-120

TO BE CENTERED ABOVE DOOR  
 W/TOP OF FRAME LINED UP WITH TOP OF WINDOWS
